FULL RESERVE STUDY

Woodridge Park Homeowners' Association, Ltd.

Orchard Park, New York
November 10, 2017

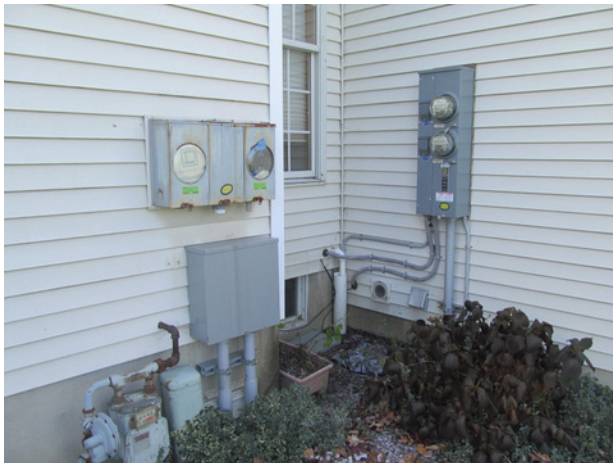
**Recently replaced electrical panels and meters
at Building 27 (note the Association should
remove original, abandoned meters and panel)**

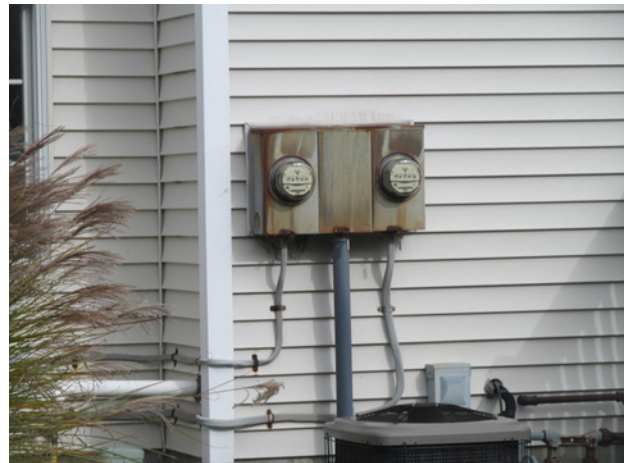
Condition: The recently replaced panels and meters are reported in good overall condition. The remaining 43 panels are in fair or fair to poor condition with rust and deterioration evident. Electrical wiring from the panels to the interior circuit breaker boxes is typically mounted at the foundation walls of the buildings. Management and the Board inform us that water infiltrates the metal panel boxes and external wiring, which causes electrical components to malfunction and fail.

**Rust and deterioration at electrical meters and
panel of Building 15**

Expenditure Detail Notes: Expenditure timing and costs are depicted in the **Reserve Expenditures** table in Section 3. We advise the Association budget for replacement of the remaining original panels and meters in a phased manner beginning by 2019 and concluding by 2047. We base our cost estimate information on historical data provided by Management and the Board. The cost information includes allowances for replacement of the exterior wiring, rerouting wiring through unit basements to reduce weathering, installation of carbon monoxide (CO) detectors and vinyl siding and sealant repairs at wiring entrance points into basements.

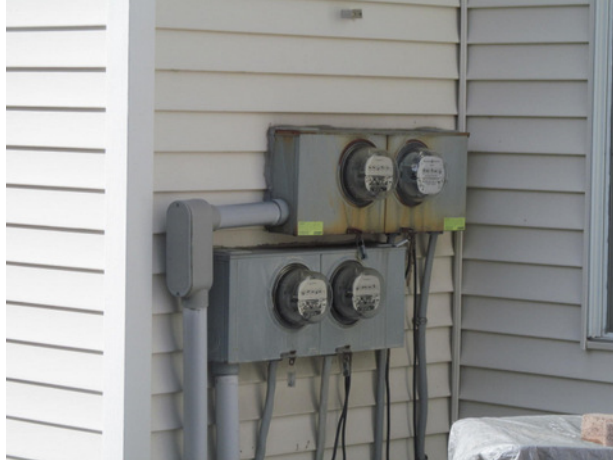
Rust and deterioration at electrical meters and panel of Building 27

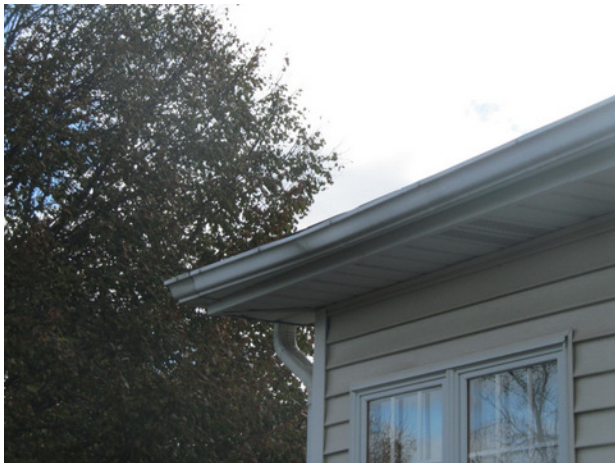
Condition: Fair overall with downspout discharge directly onto lower roof sections, displacement, previous repairs and partial replacements, damaged downspout connectors and deterioration evident

Displaced and deteriorated aluminum gutter at Building 18

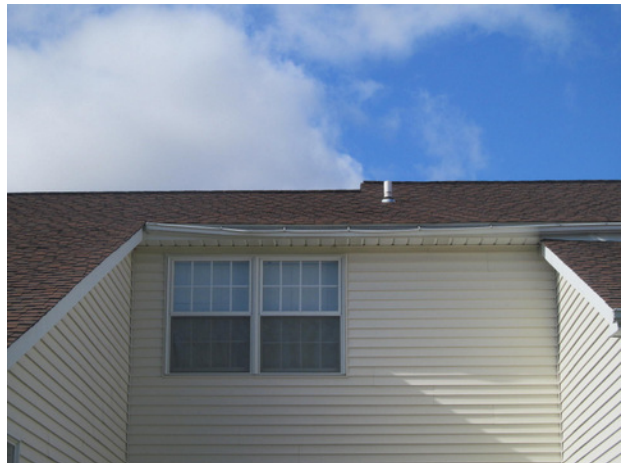
Displaced and deteriorated aluminum gutter at Building 37

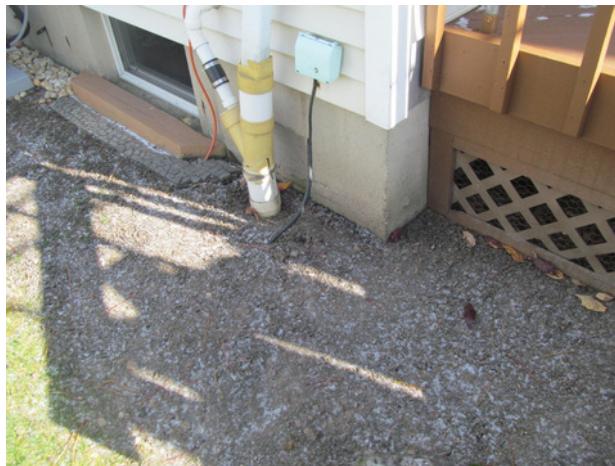
Broken, damaged and deterioration downspout connector at 32 Southwick Drive

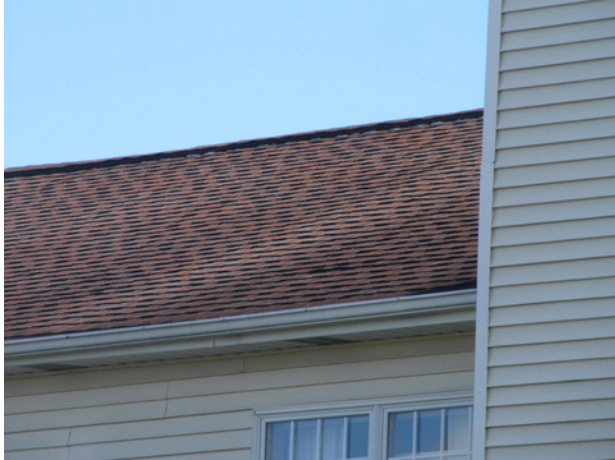
Shingle lift and deterioration at asphalt shingle roof of Building 26

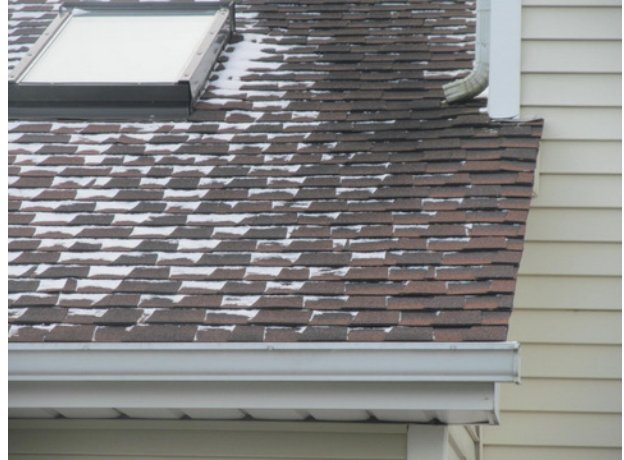
Shingle lift, stains and deterioration at asphalt shingle roof of Building 12

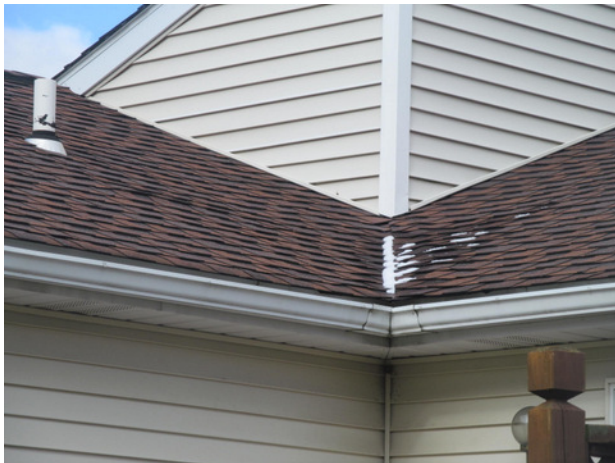
Shingle lift and deterioration at asphalt shingle roof of Building 15

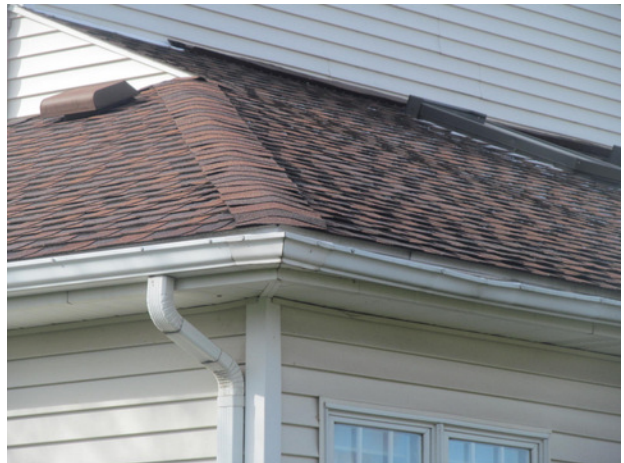
Shingle lift and deterioration at asphalt shingle roof of Building 22

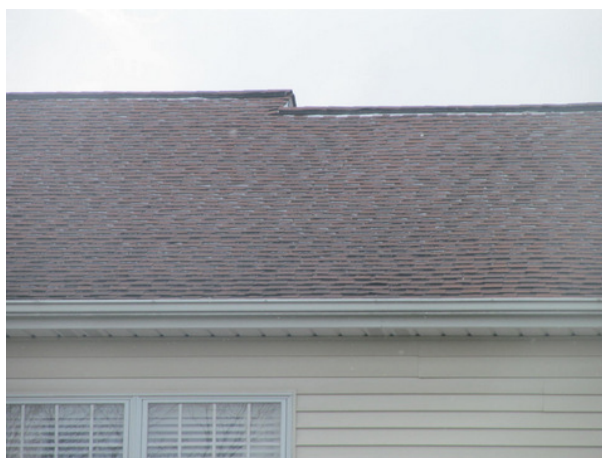
Shingle lift and deterioration at asphalt shingle roof of Building 5

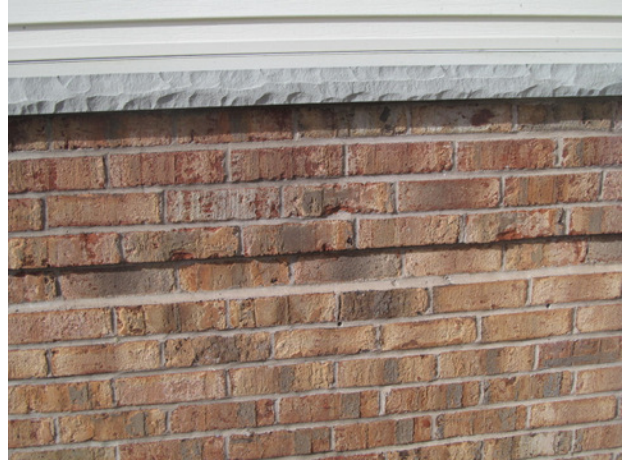
Isolated area of minor spalling at masonry wall of Building 2

Useful Life: We advise a complete inspection of the masonry and related masonry repairs every 12- to 18-years to forestall deterioration.

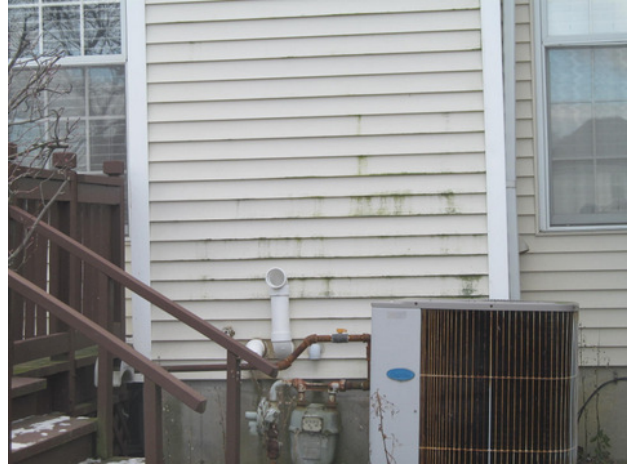
Organic stains and deterioration at Building 6

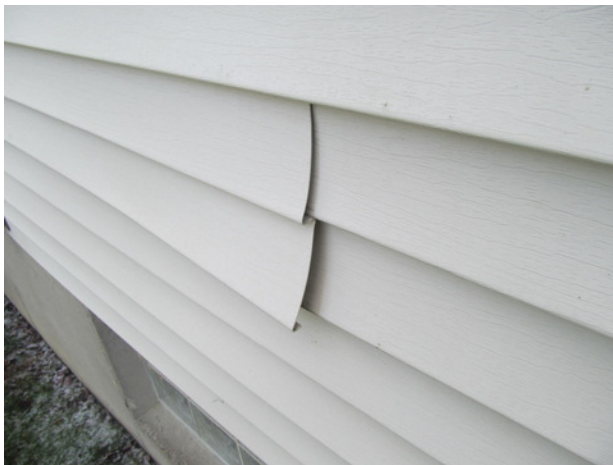
Loose siding and deterioration at vinyl siding of Building 4

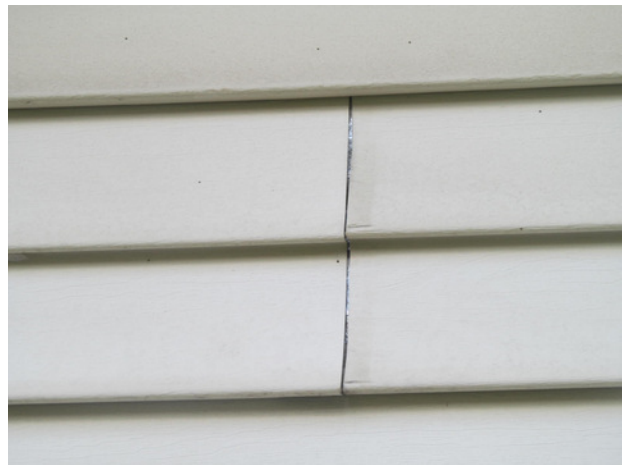
Gaps and deterioration at vinyl siding of Building 1

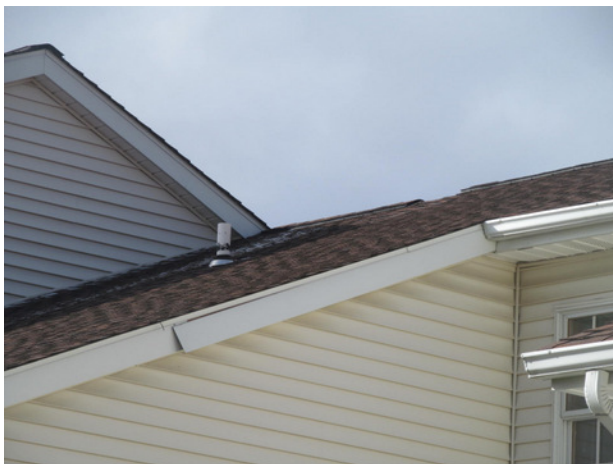
Loose cladding and deterioration at fascia of Building 20

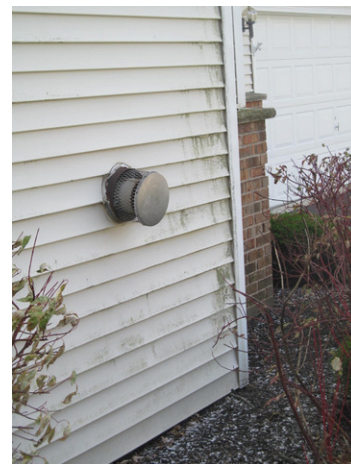
Organic stains and deterioration at vinyl siding of Building 20

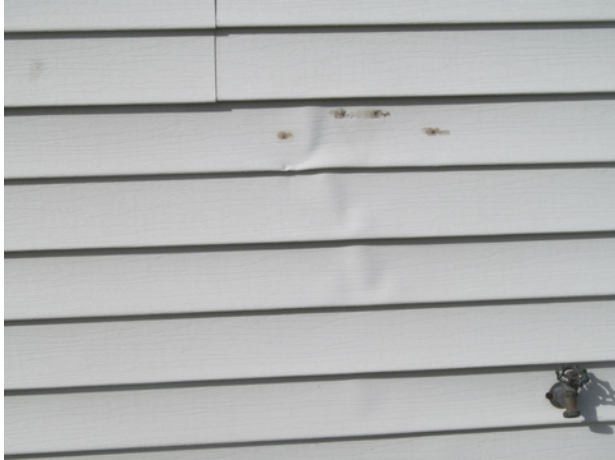
Warping and deterioration at vinyl siding of Building 19

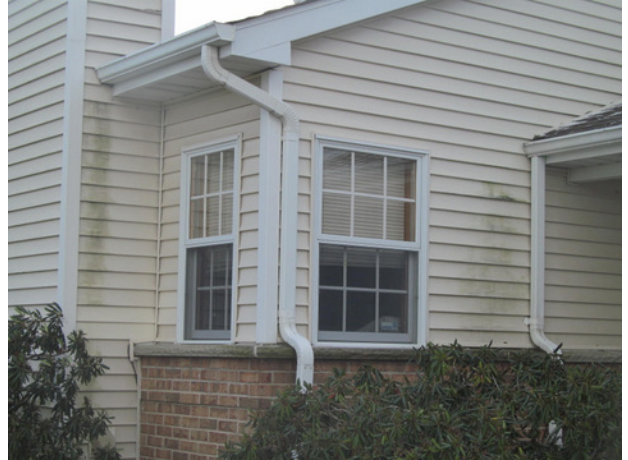
Organic stains and deterioration at vinyl siding of Building 18

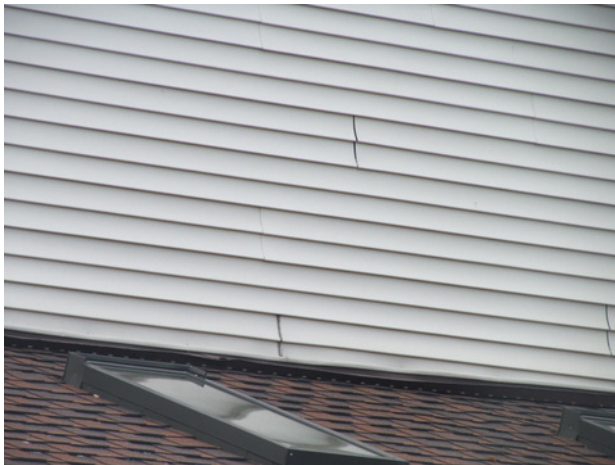
Gaps and deterioration at vinyl siding of Building 17

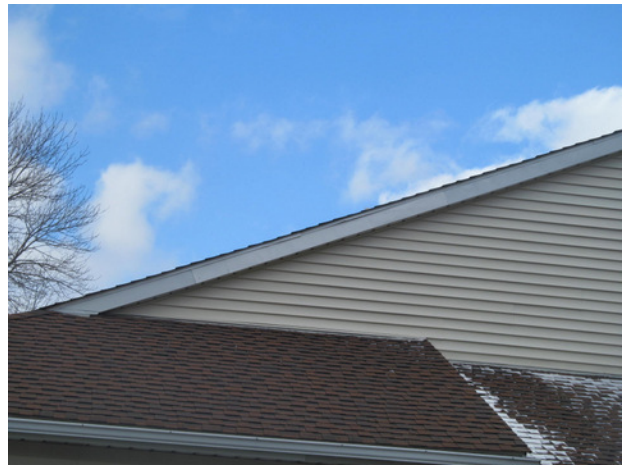
Previous partial fascia cladding replacement at Building 17

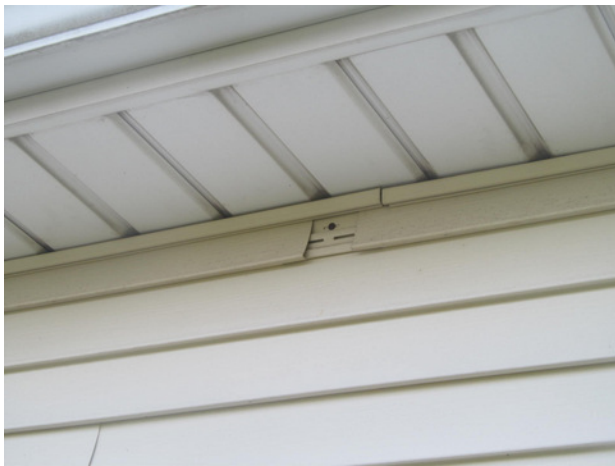
Gaps and deterioration at vinyl siding of Building 15

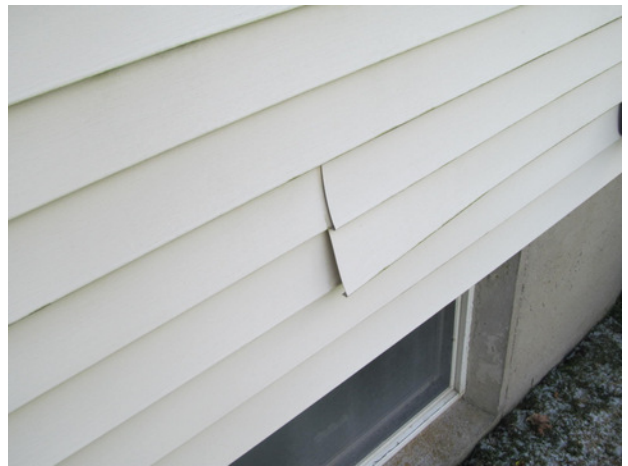
Loose siding and deterioration at vinyl siding of Building 10

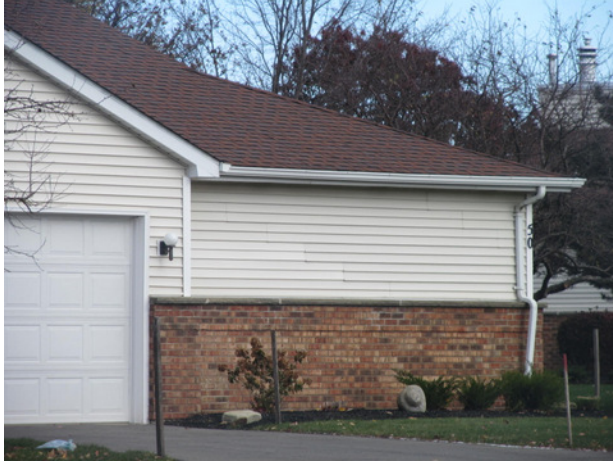
Previous partial vinyl siding replacement at Building 5

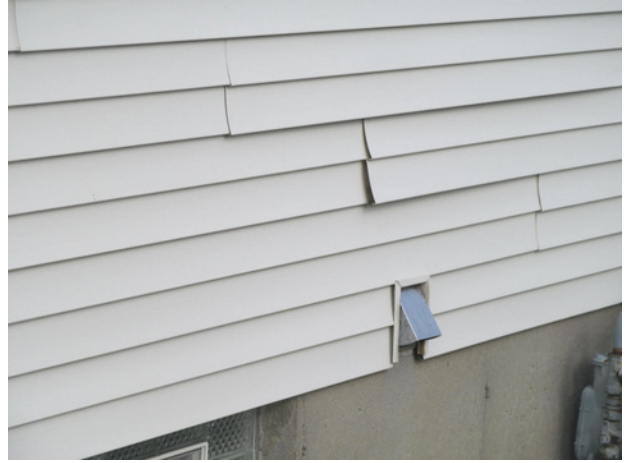
Loose siding and deterioration at vinyl siding of Building 32

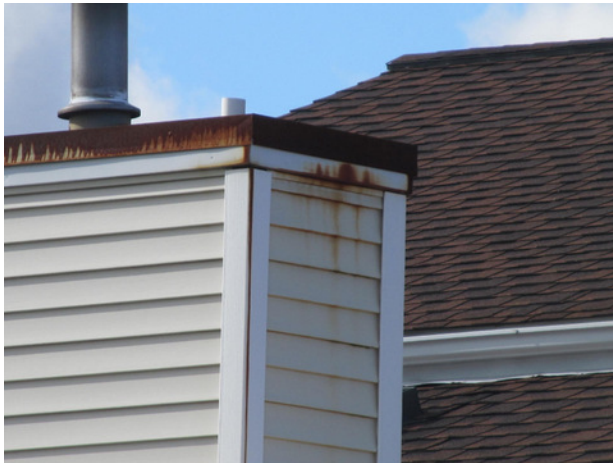
Stains and deterioration at vinyl siding of Building 30 due to chimney cap rust

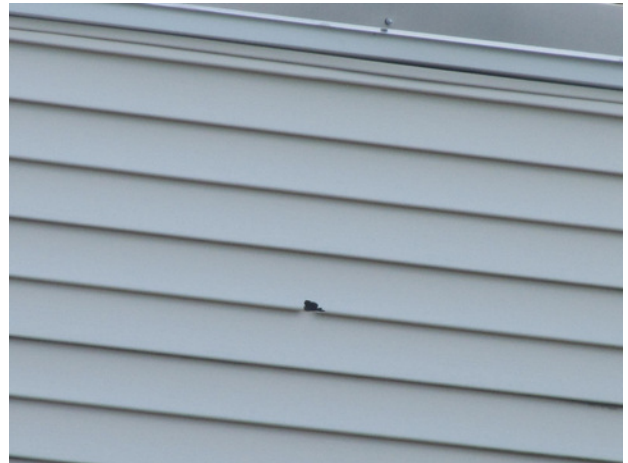
Damage and deterioration at vinyl siding of Building 24

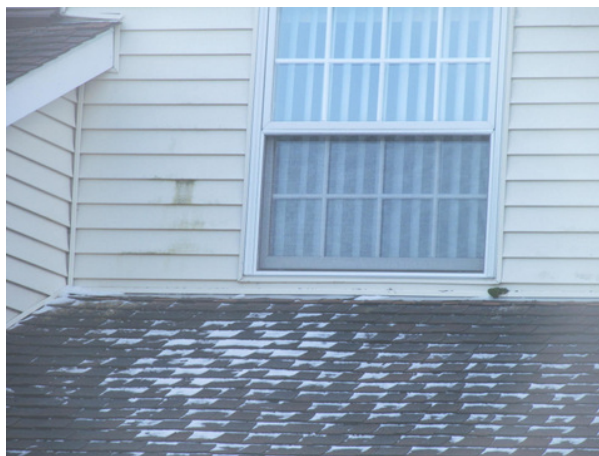
Stains, organic growth and deterioration at vinyl siding of 146 Southwick Drive

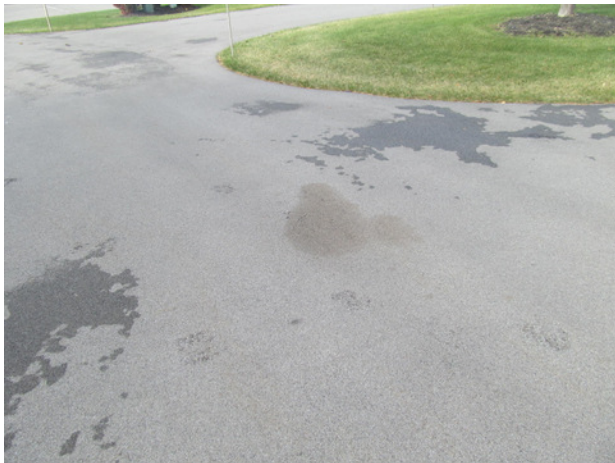
Isolated vehicle fluid stain and deterioration at asphalt driveway of 130 Southwick Drive

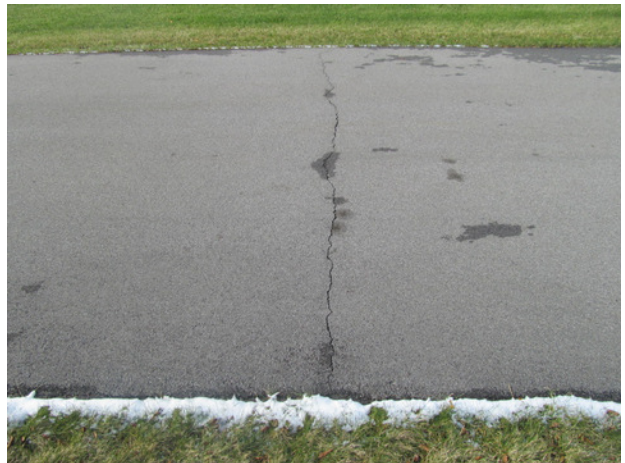
Lateral cracks and deterioration at asphalt access drive near of 130 Southwick Drive

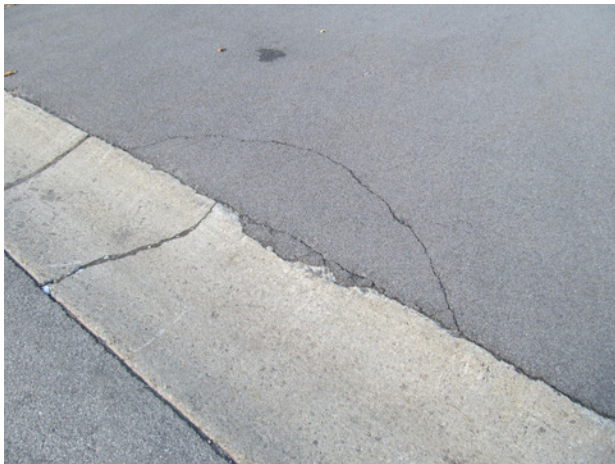
Edge cracks and deterioration at asphalt access drive near Building 6

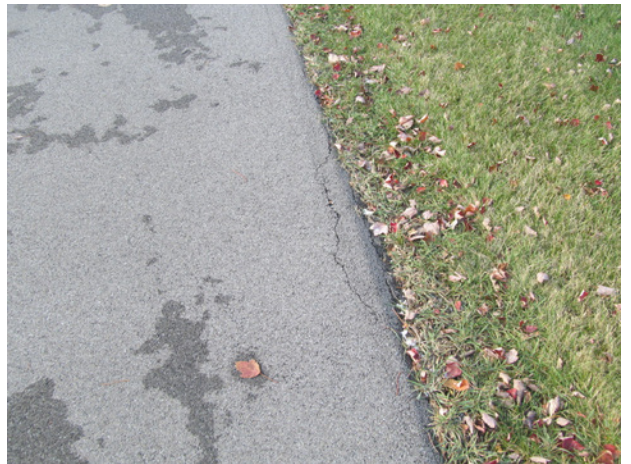
Edge cracks and deterioration at asphalt driveway of 146 Southwick Drive

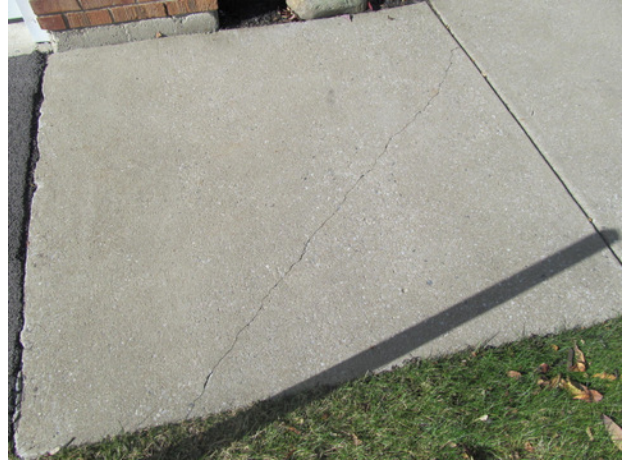
Localized crack and deterioration at concrete sidewalk near Building 25

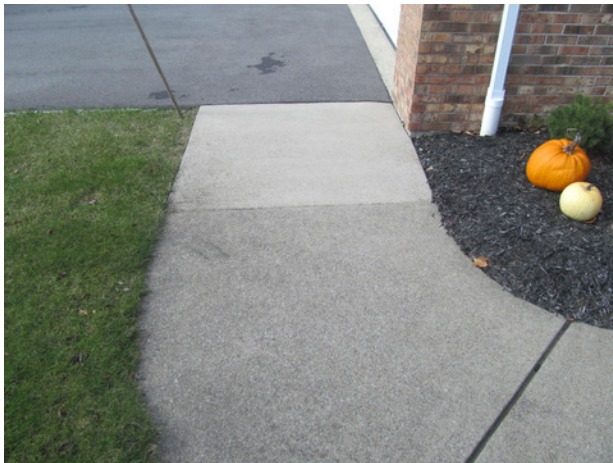
Previous partial concrete sidewalk replacement near Building 29

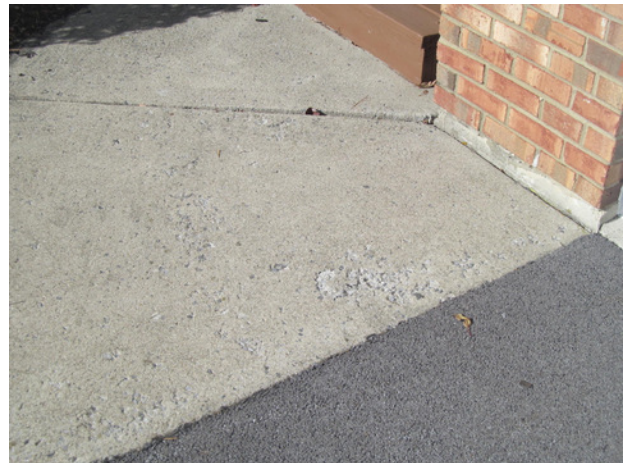
Isolated spalling and deterioration at concrete sidewalk near 26 Crabapple Court

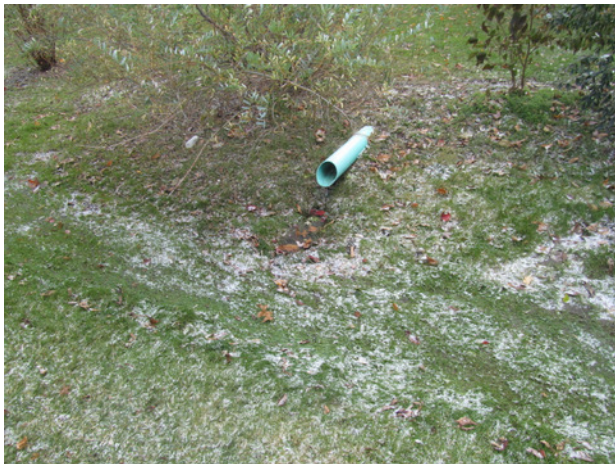
Minor erosion and deterioration at wall of drainage swale near Building 1

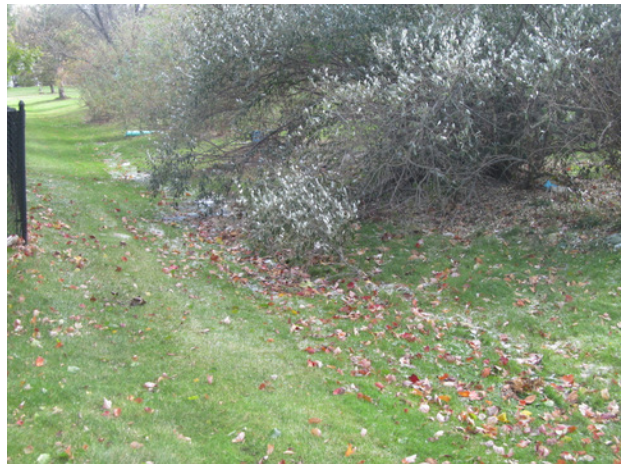
Tree branch obstruction at drainage swale near Building 1

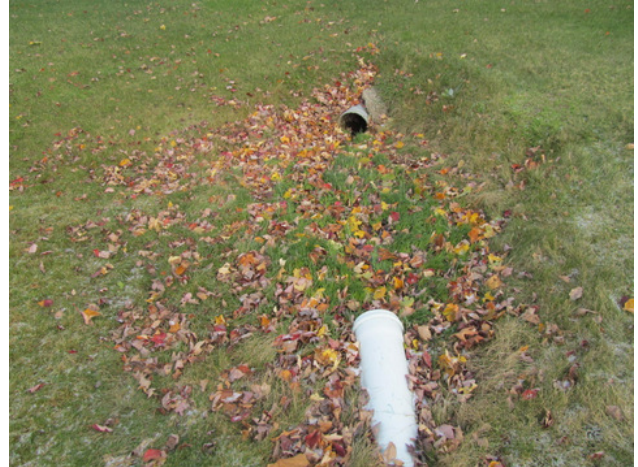
Silt and soil buildup evident at drainage culverts near Building 22

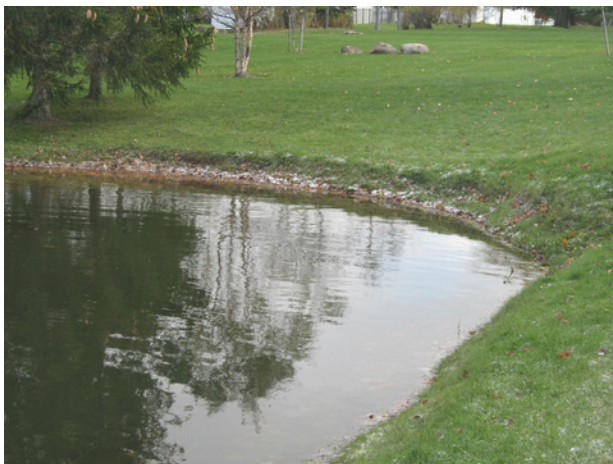
Isolated shoreline erosion and deterioration along east portion of pond shoreline

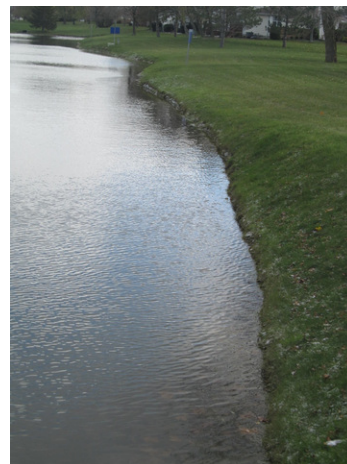
Localized shoreline erosion and deterioration along west portion of pond shoreline

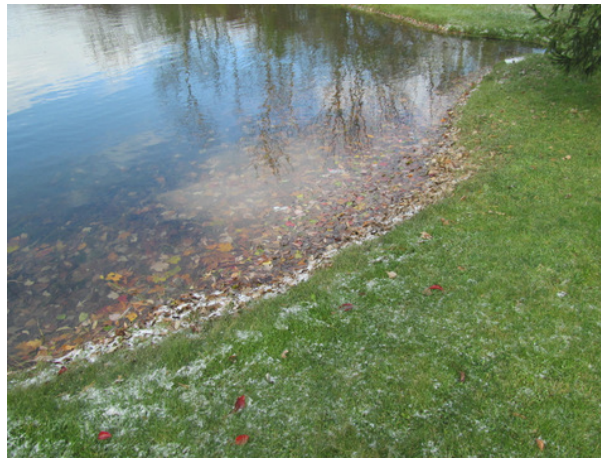
Isolated area of natural debris at the east section of the pond
