FULL RESERVE STUDY

Woodridge Park Homeowners' Association, Ltd.

Orchard Park, New York
November 10, 2017

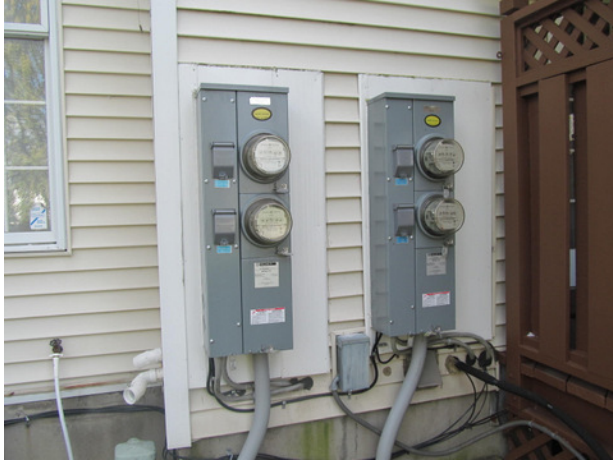
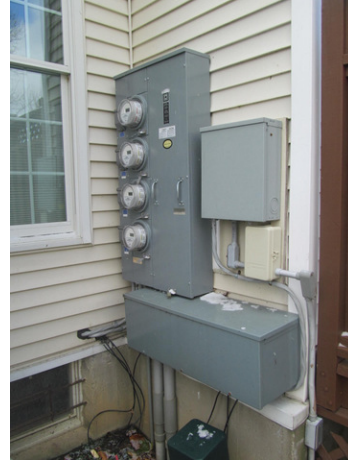
Condition: The recently replaced panels and meters are reported in good overall condition. The remaining 43 panels are in fair or fair to poor condition with rust and deterioration evident. Electrical wiring from the panels to the interior circuit breaker boxes is typically mounted at the foundation walls of the buildings. Management and the Board inform us that water infiltrates the metal panel boxes and external wiring, which causes electrical components to malfunction and fail.

**Recently replaced electrical panels and meters
(note good condition)**

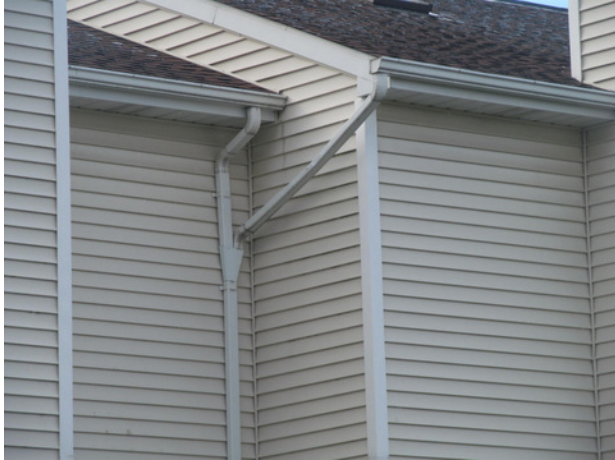
Condition: Fair overall with downspout discharge directly onto lower roof sections, displacement, previous repairs and partial replacements, damaged downspout connectors and deterioration evident

Aluminum gutter and downspout overview

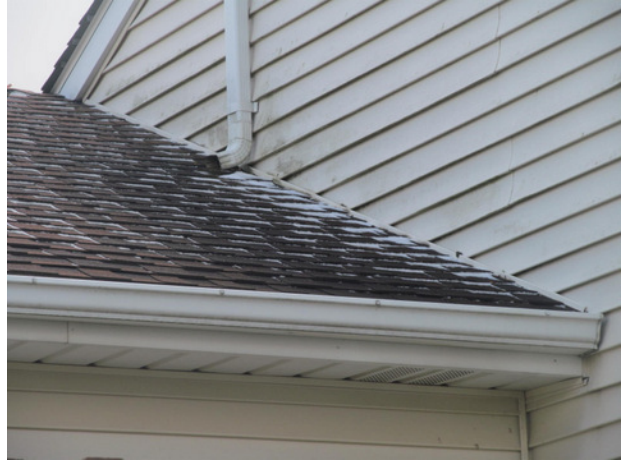
Typical downspout discharge directly onto lower asphalt shingle roof

Component Detail Notes: Downspouts that discharge directly onto roofs cause premature deterioration of the roofs due to the high concentration of storm water. We recommend either routing these downspouts directly to the ground, connecting the downspouts to the gutters of the lower roof or distributing the storm water discharge over a large area.

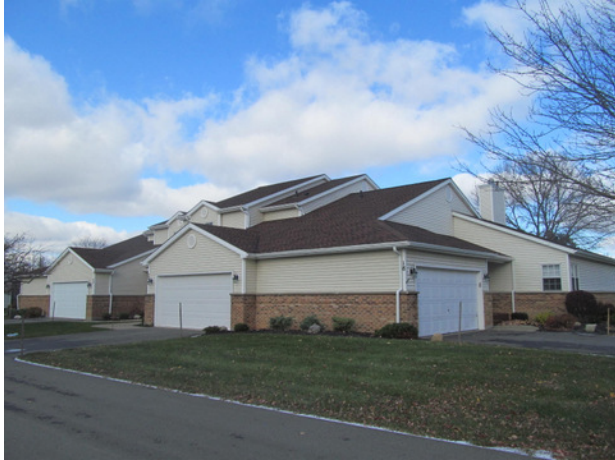
Condition: The roof at Building 2 is in good overall condition with no visible deterioration. The remaining roofs are in good to fair overall condition with shingle lift, stains and deterioration evident from our visual inspection from the ground. Management and the Board inform us of a history of isolated leaks and ice dams due to a large storm in 2014; however, none are currently active.

Asphalt shingle roof overview at Building 2

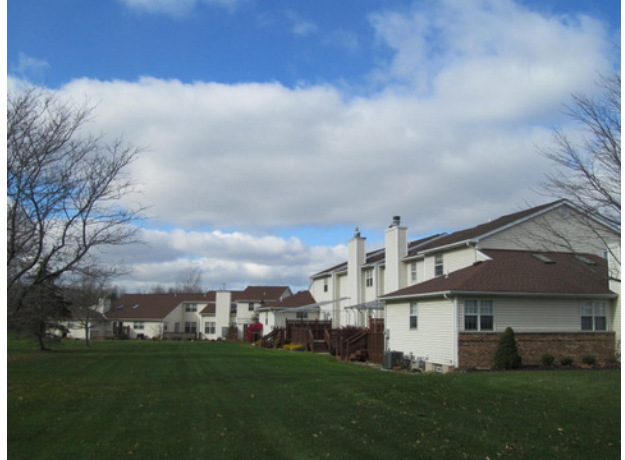
Asphalt shingle roof overview at remaining buildings

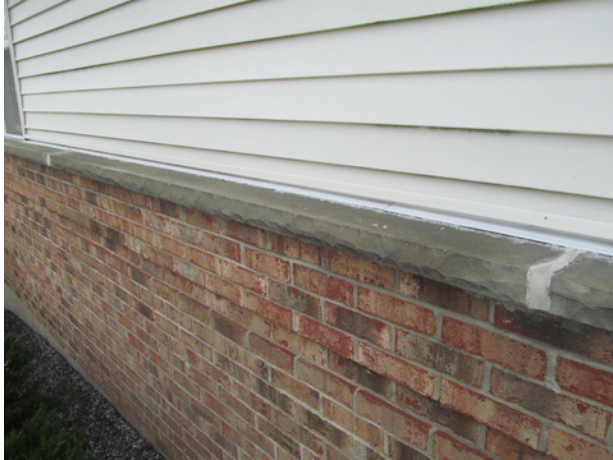
- Extensive previous repairs and realignment of masonry sills
- Efflorescence is not visible
- Masonry exhibits isolated areas of minor cracks
- Masonry exhibits localized areas of minor spalls
- Minor mortar deterioration is evident
- Mortar joints are tooled

Masonry wall overview (note masonry sill)

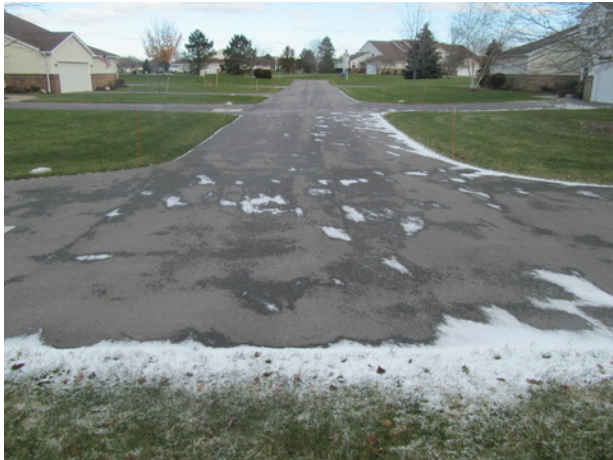
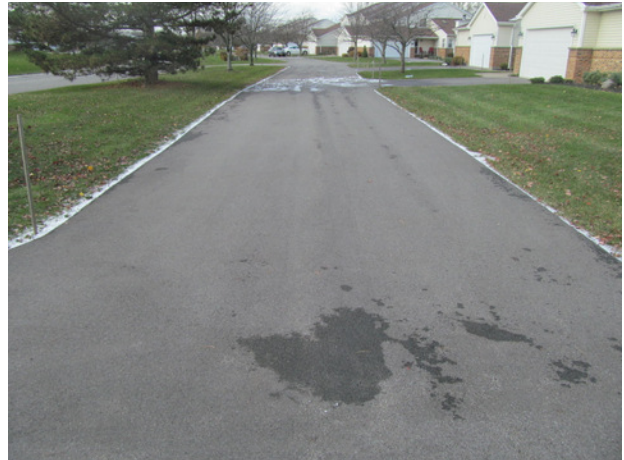
Condition: Good overall with localized areas of vehicle fluid stains, lateral and edge cracks, and deterioration evident

Asphalt access drive overview

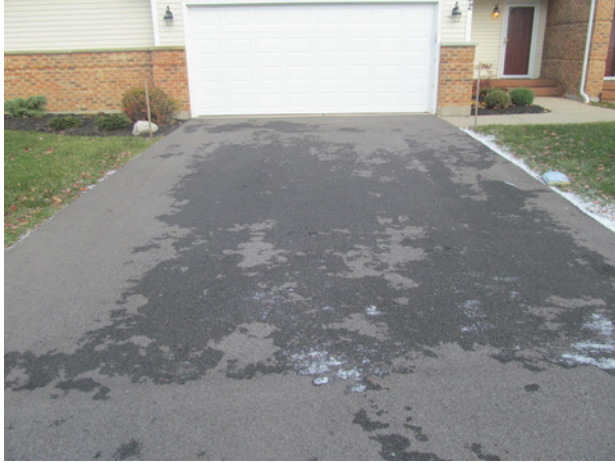
Asphalt driveway overview

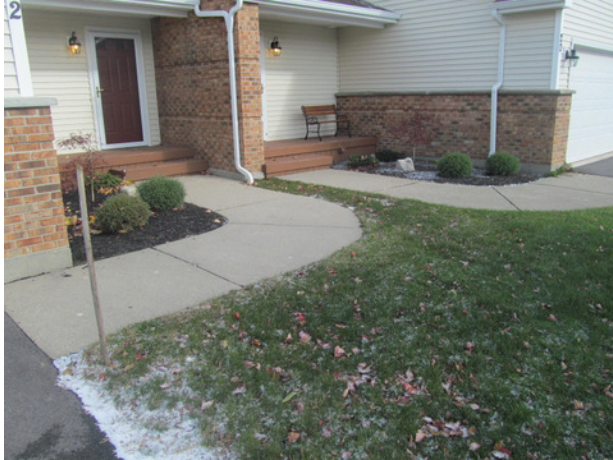
Condition: Good to fair overall with localized areas of cracks, spalling, previous partial replacements and deterioration evident; Management and the Board apprise us that the Association recently mudjacked and leveled up to 20 locations of sidewalks

Concrete sidewalk overview

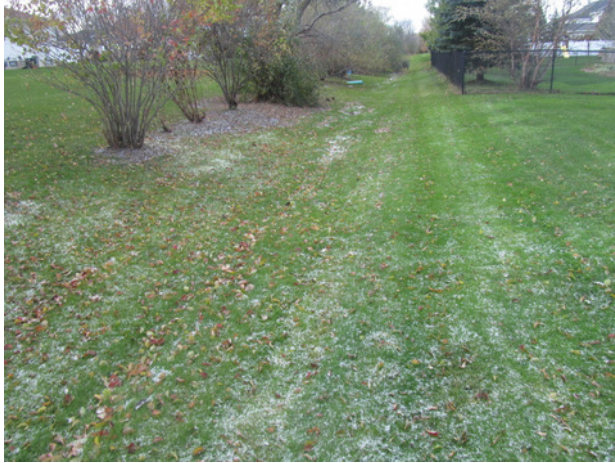
Condition: Good to fair condition with localized areas of erosion, silt and soil buildup at culvert pipes, tree branch obstructions and deterioration evident

Drainage swale overview (northeast section of the property)

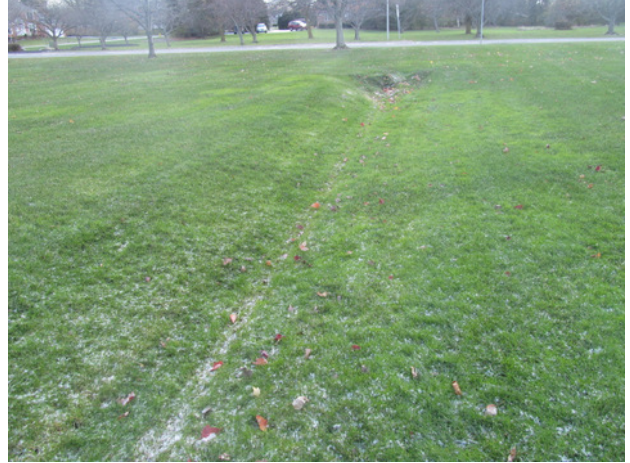
Drainage swale overview (near the community's entrance)

Expenditure Detail Notes: Expenditure timing and costs are depicted in the **Reserve Expenditures** table in Section 3. Our cost estimate includes allowances for a complete inspection and capital repairs of up to three percent (3%), or 30 linear feet, of swales.

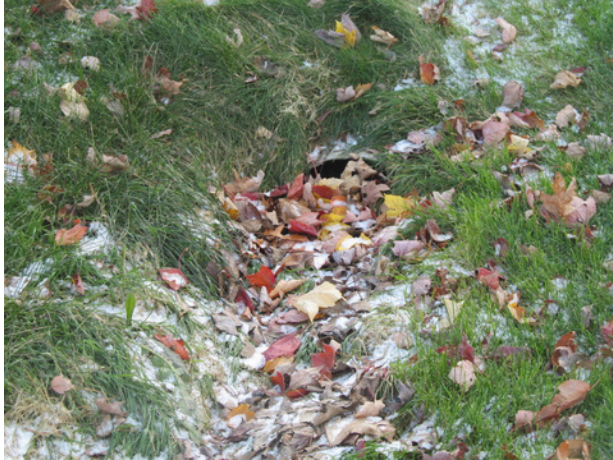
Silt and soil buildup evident at drainage culvert near Building 1

Component Detail Notes: The Association should maintain the drainage swales to prevent erosion to impenetrable material, e.g. bedrock. When this type of erosion occurs, the walls of the drainage swales will begin to erode and expand, causing accelerated deterioration of the adjacent landscape. Capital repairs may vary based on location and the extent of deterioration. Typical capital repairs include, but are not limited to, regrading and/or augmenting topsoil at swale beds and walls, installing rip-rap and modifying landscaping along the drainage swales. These erosion control measures may not completely eliminate drainage swale deterioration. Therefore, the Association may anticipate less significant, interim repairs to the drainage swales in the future and should fund these activities through the operating budget.

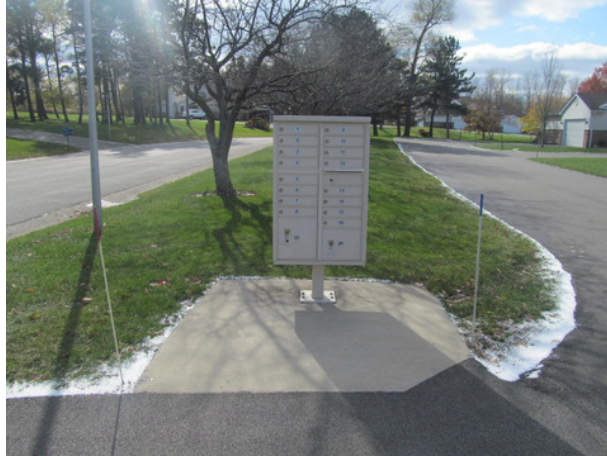
Condition: Good overall

Typical mailbox station

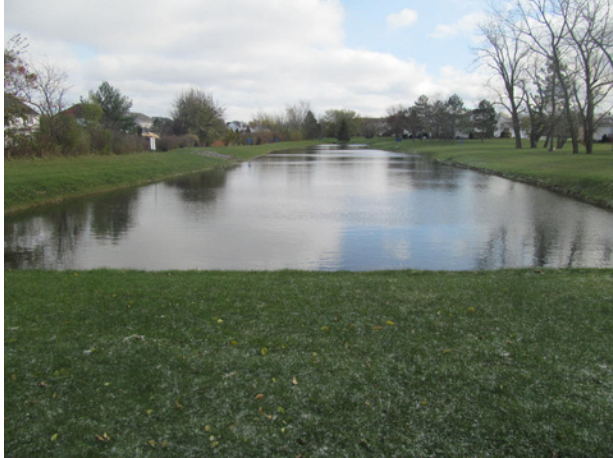
Condition: The pond is in good to fair condition with isolated areas of natural debris present.

Pond overview

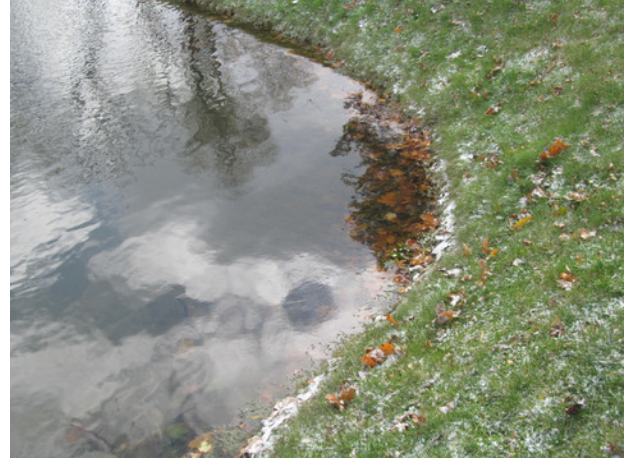
Isolated area of natural debris at the west section of the pond

need to remove fifty percent (50%), or 2,350 square yards of the surface area an average depth of one yard. However, the actual volume of material to remove may vary dependent upon an invasive analysis at the time of removal. A visual inspection of a body of water cannot reveal the amount of accumulated silt. This is especially true on larger bodies of water. It is therefore inaccurate to assume an entire body of water will require sediment removal. It is more cost effective to spot remove in areas of intense silt accumulation as noted through bathymetric surveys. The amount or depth of silt is determined through prodding into the silt until a relatively solid base is found or through bathymetric surveys. A bathymetric survey establishes a base of data about the depth of the body of water over many locations against which the data of future surveys is compared. These invasive procedures are beyond the scope of a Reserve Study and require multiple visits to the site. We recommend Woodridge Park contract with a local engineer for periodic bathymetric surveys. Future updates of the Reserve Study can incorporate future anticipated expenditures based on the results of the bathymetric surveys.

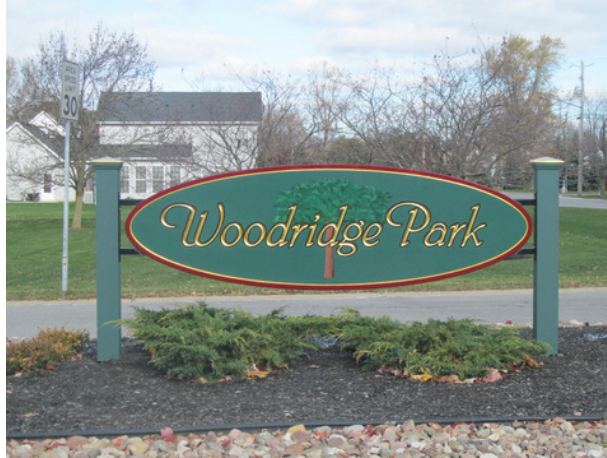
Condition: Good overall

Community identification signage overview
